EVALUATION OF ELECTROSTATIC PROBE
TECHNIQUE FOR DETECTION OF PARTICLES
EMITTED DURING TURBINE ENGINE
DISTRESS

Air Force Aero Propulsion Laboratory
Wright-Patterson Air Force Base, Ohio

November 1974

3. REPORT TITLE		
EVALUATION OF ELECTROSTATIC PROBE TECHNIQUE FOR DETECTION OF PARTICLES EMITTED DURING TURBINE ENGINE DISTRESS		
4. DESCRIPTIVE NOTES (Type of report and inclusive dates)		
Final - 15 Jan 74 - 15 Mar 74

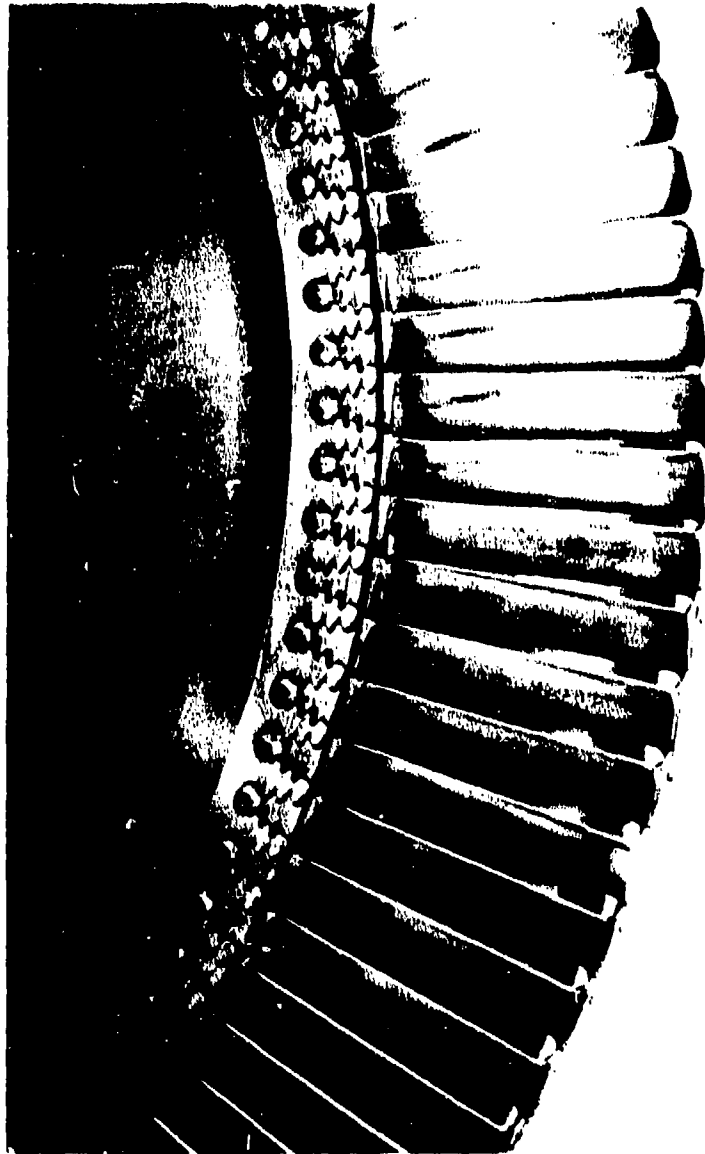
Figure 6. Rub Area on HP Turbine

enters station 6. Then when the thrust level was reduced to idle, rotor shift allowed rub between the rod and the base area of the blades. The actual rub location is shown in the photo of Figure 6.

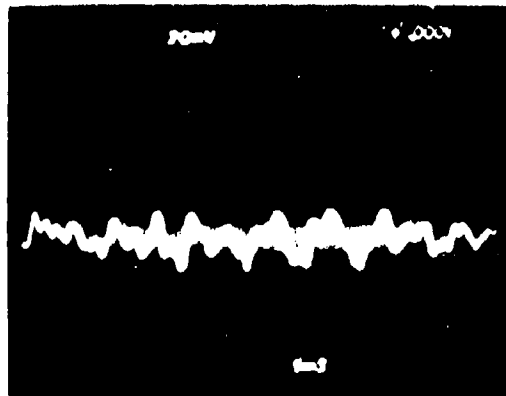
Figure 16. Noise Pulse Into 1 Mohm

Remarks: Typical low level background noise into 1M Ω termination (similar DC level fluctuations have been observed to some extent on all other engines). This type noise was not counted by the probe electronic systems, since these systems provide 93 Ω termination, the characteristic cable impedance, which greatly attenuates the signal and prevents cable reflections.

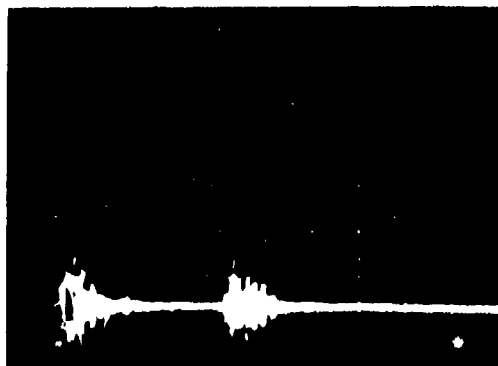
Figure 17. Noise Pulse Into 50 Ohms.

No recognizable particle signals, but much low-level noise observed on oscilloscope. See Figures 16 and 17.

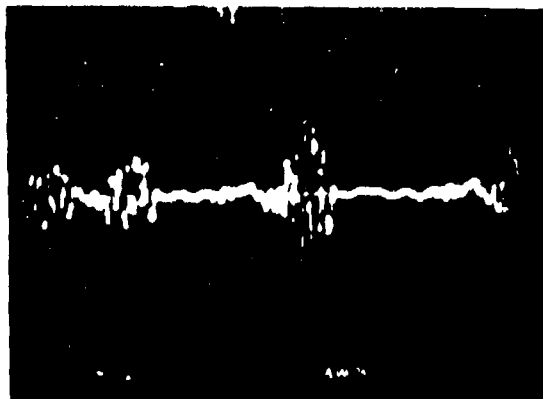
Figure 22. Noise Pulses, Test #3a

Remarks: Probe A6 was connected to MCA#1. MCA#1 recorded one shower and a total of six positive pulses. The signals have the general appearance of electrical interference. The oscillatory pulses in this case arrived at irregular intervals. The origin of these signals was not determined.

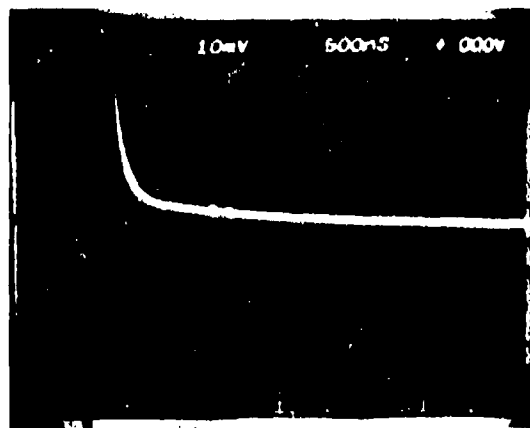
Figure 26. "Normal" J57 Type Pulse, Test #3b

Remarks: Probe B17 was connected to ACAPS#2. (This type of pulse has been observed on other J57s.) The rub-rod was inserted and the J57 was accelerated to a thrust of 9000lbs. This pulse was recorded about 30 seconds after acceleration and the ACAPS #2 recorded three counts. This monopolar pulse implies a net charge transfer to the probe, and may therefore be interpreted as charged particle detection, although a proposed alternative explanation is static discharge due to arcing at the probe surface.

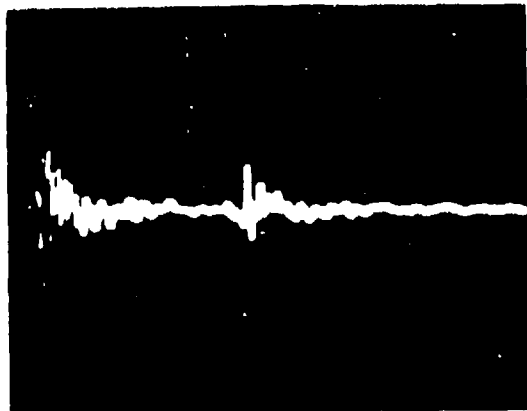
Figure 27. Noise Pulse, Test #3b

At time 1430, nine counts were recorded on probe D30. The appearance of these signals (Figure 27) is not clearly "random" noise, but is more characteristic of electrical interference from an outside source.

Remarks: These pulses were recorded when the J57 was returned to idle condition. During this time MCA#3 also recorded nine pulses. The origin of these pulses could not be determined, although the oscillatory appearance is characteristic of transient electrical interference.

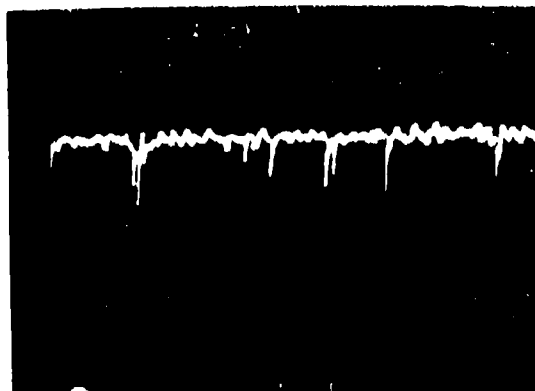
Figure 34. Negative Pulses Into 1 Mohm, Test #5

Remarks: Probe A6 was connected to MCA#1. The MCA#1 did not count these pulses because it was set to count positive pulses. Also, the amplitude was less than 50mv when the cable was terminated into 93 ohms. This photo shows the type of signals seen during rub-rod insertion, though similar pulses were observed during non-distress periods. (See also Single trace below.)

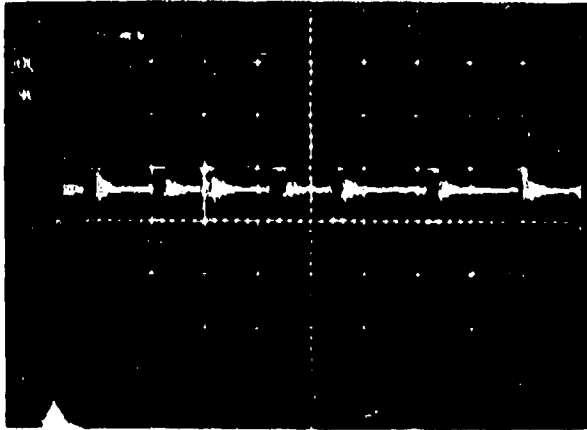
Figure 47. Noise Pulse, Test #9

Many counts recorded throughout the entire run, but all appeared to be noise similar to that due to bad probe cable connections. (See Figure 47.) The actual origin of these signals could not be resolved, although at least one cable was determined to have a faulty line, thus accounting for a very high count rate.
